Combustion heat and head gasket destruction

by Gene Hailey

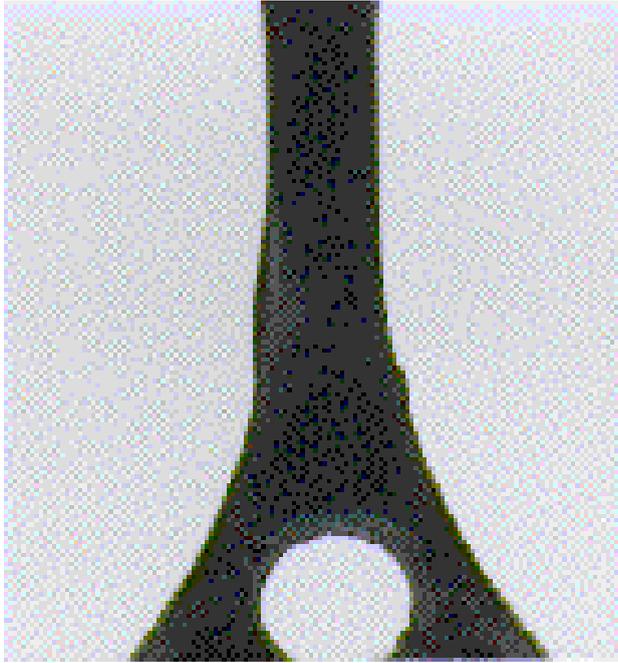
How does all this affect the survival of the gasket? Engines with exhaust valves adjacent to each other such as the small block Chevys and engines with Siamese cylinders are highly prone to developing localized hot spots when the lean burn is uncontrolled. The increased crush of the gasket causes the steel to flatten out or widen and bulge over the edge of the cylinder. (see photo below)

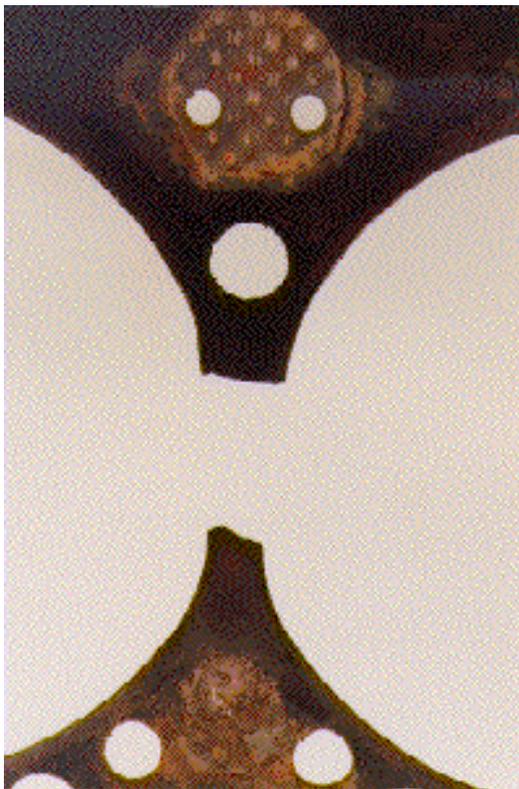
This situation exposes the gasket to greater temperatures and eventually starts burning the steel fire ring of the gasket, once the burning starts, it burns completely across the gasket to the adjacent cylinder in a short time (photo below). The thickness reduction also allows the exhaust gasses to seep over the gasket which adds to the problem.
