Failure Diagnosis – Localised Hotspots

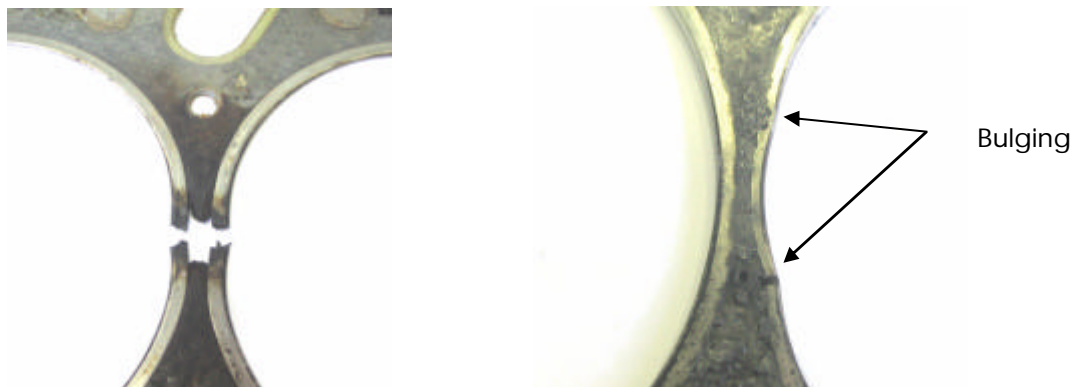
Localised hot spots are one of the more easily identifiable causes of a head gasket failure. A hot spot causes the surrounding metal in the cylinder block and head to expand which in turn can crush and damage the head gasket, creating a leak where the exhaust gases will erode the gaskets facing material. Eventually the escaping exhaust gases will burn through the gaskets fire rings and steel core.

Hot spots in a cylinder block or head are caused by localised overheating. When a hot spot forms the surrounding metal expands greatly creating added stress, which may cause the head to warp or even crack. The extreme temperature of a hot spot can also cause a localised soft spot in the cylinder head.

A cooling system that is not operating efficiently, loss or lack of coolant, an air pocket in the cooling system, or an abnormal combustion problem that causes combustion temperatures to increase dramatically can result in the formation of a localised hot spot. Aluminum cylinder heads where the exhaust valves for the two centre cylinders are positioned back to back are also prone to localised overheating between the adjacent sets of valves.
